I Sense a System Failure

By Lt. Rich Hansen

Who Ate the Ritz Bits?

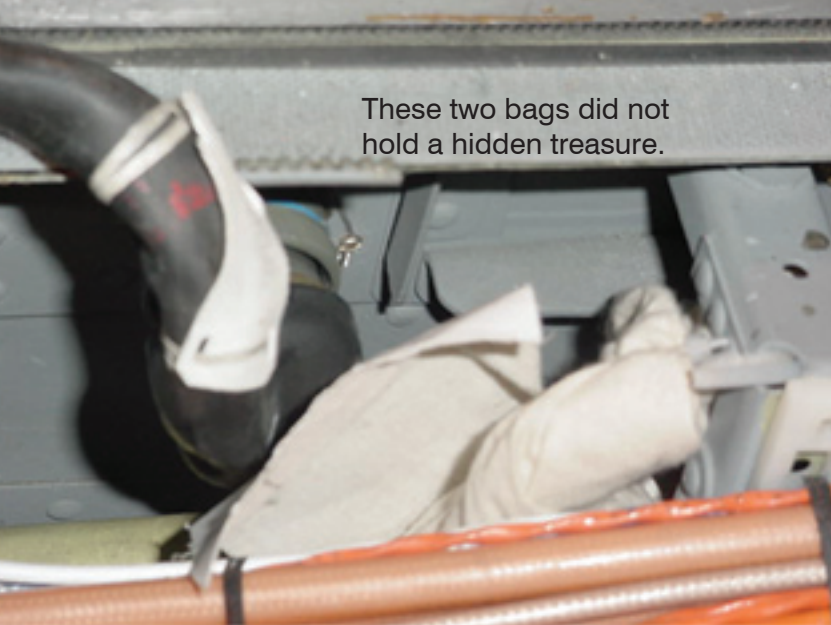
These two bags did not hold a hidden treasure.

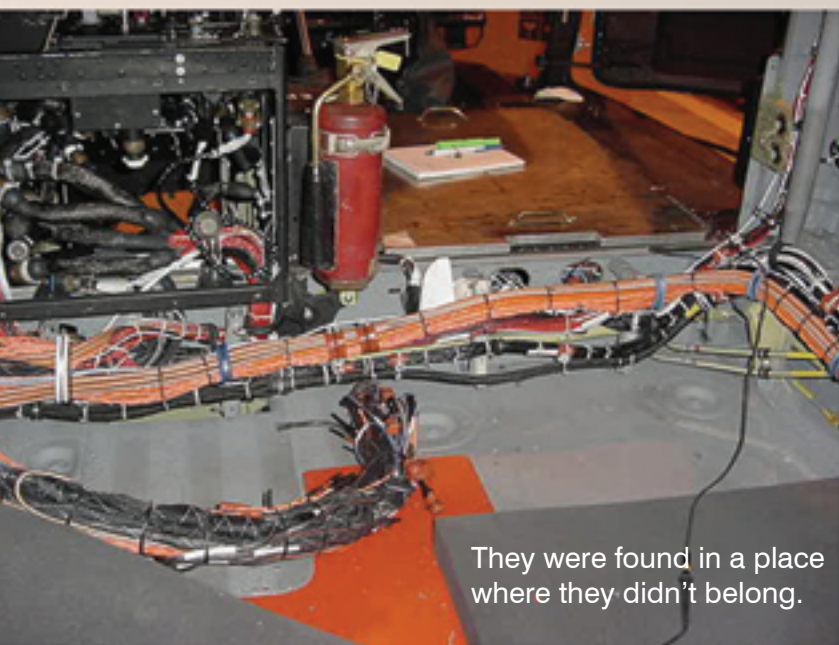
They were found in a place where they didn't belong.

The receiving command called us a few days after the transfer and said we had neglected one tiny detail. During the modification, the original wire-bundle bracket bolts were removed to allow room for the new wire bundle. Those four bolts were wrapped neatly in a parts bag and zip-tied just above the wire harness and the collective push rod. We had done that so no one would forget to re-install them. Oh...the best-laid plans.

We had failed to use those rock-solid, in-process procedures I told you about: We didn't document the removal of the forward cabin's kick panel. That mistake was bad enough, but the problem was compounded when a mystery mechanic removed the wire-bracket bolts and neatly stowed them in that cavity. Multiple tasks were involved with the maintenance on that aircraft, and we still don't know who removed the bolts, or why paperwork wasn't initiated. We also didn't communicate—an important lesson learned.

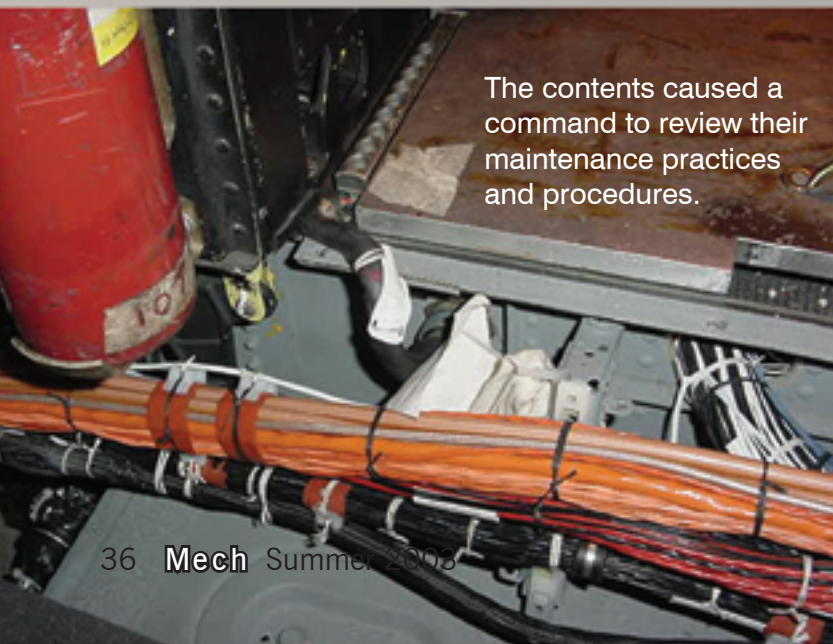
The contents caused a command to review their maintenance practices and procedures.

This simple error, when teamed with the lack of paperwork on the panel and bracket bolts, allowed us to miss the need for a final product inspection. If everyone does his job, follows the processes and procedures, documents all work, and communicates, no one ever again will have to write this type of article.✈
